**Sacramento River Flood Control System Evaluation  
Initial Appraisal Report - Lower Sacramento Area**

**Basis of Design  
Geotechnical Evaluation of Levees  
February 1993**

BASIS OF DESIGN  
GEOTECHNICAL EVALUATION OF LEVEES  
FOR  
SACRAMENTO RIVER FLOOD CONTROL SYSTEM EVALUATION  
LOWER SACRAMENTO RIVER AREA, PHASE IV

PREPARED BY  
SOIL DESIGN SECTION, GEOTECHNICAL BRANCH  
U.S. ARMY ENGINEER DISTRICT, SACRAMENTO  
CORPS OF ENGINEERS

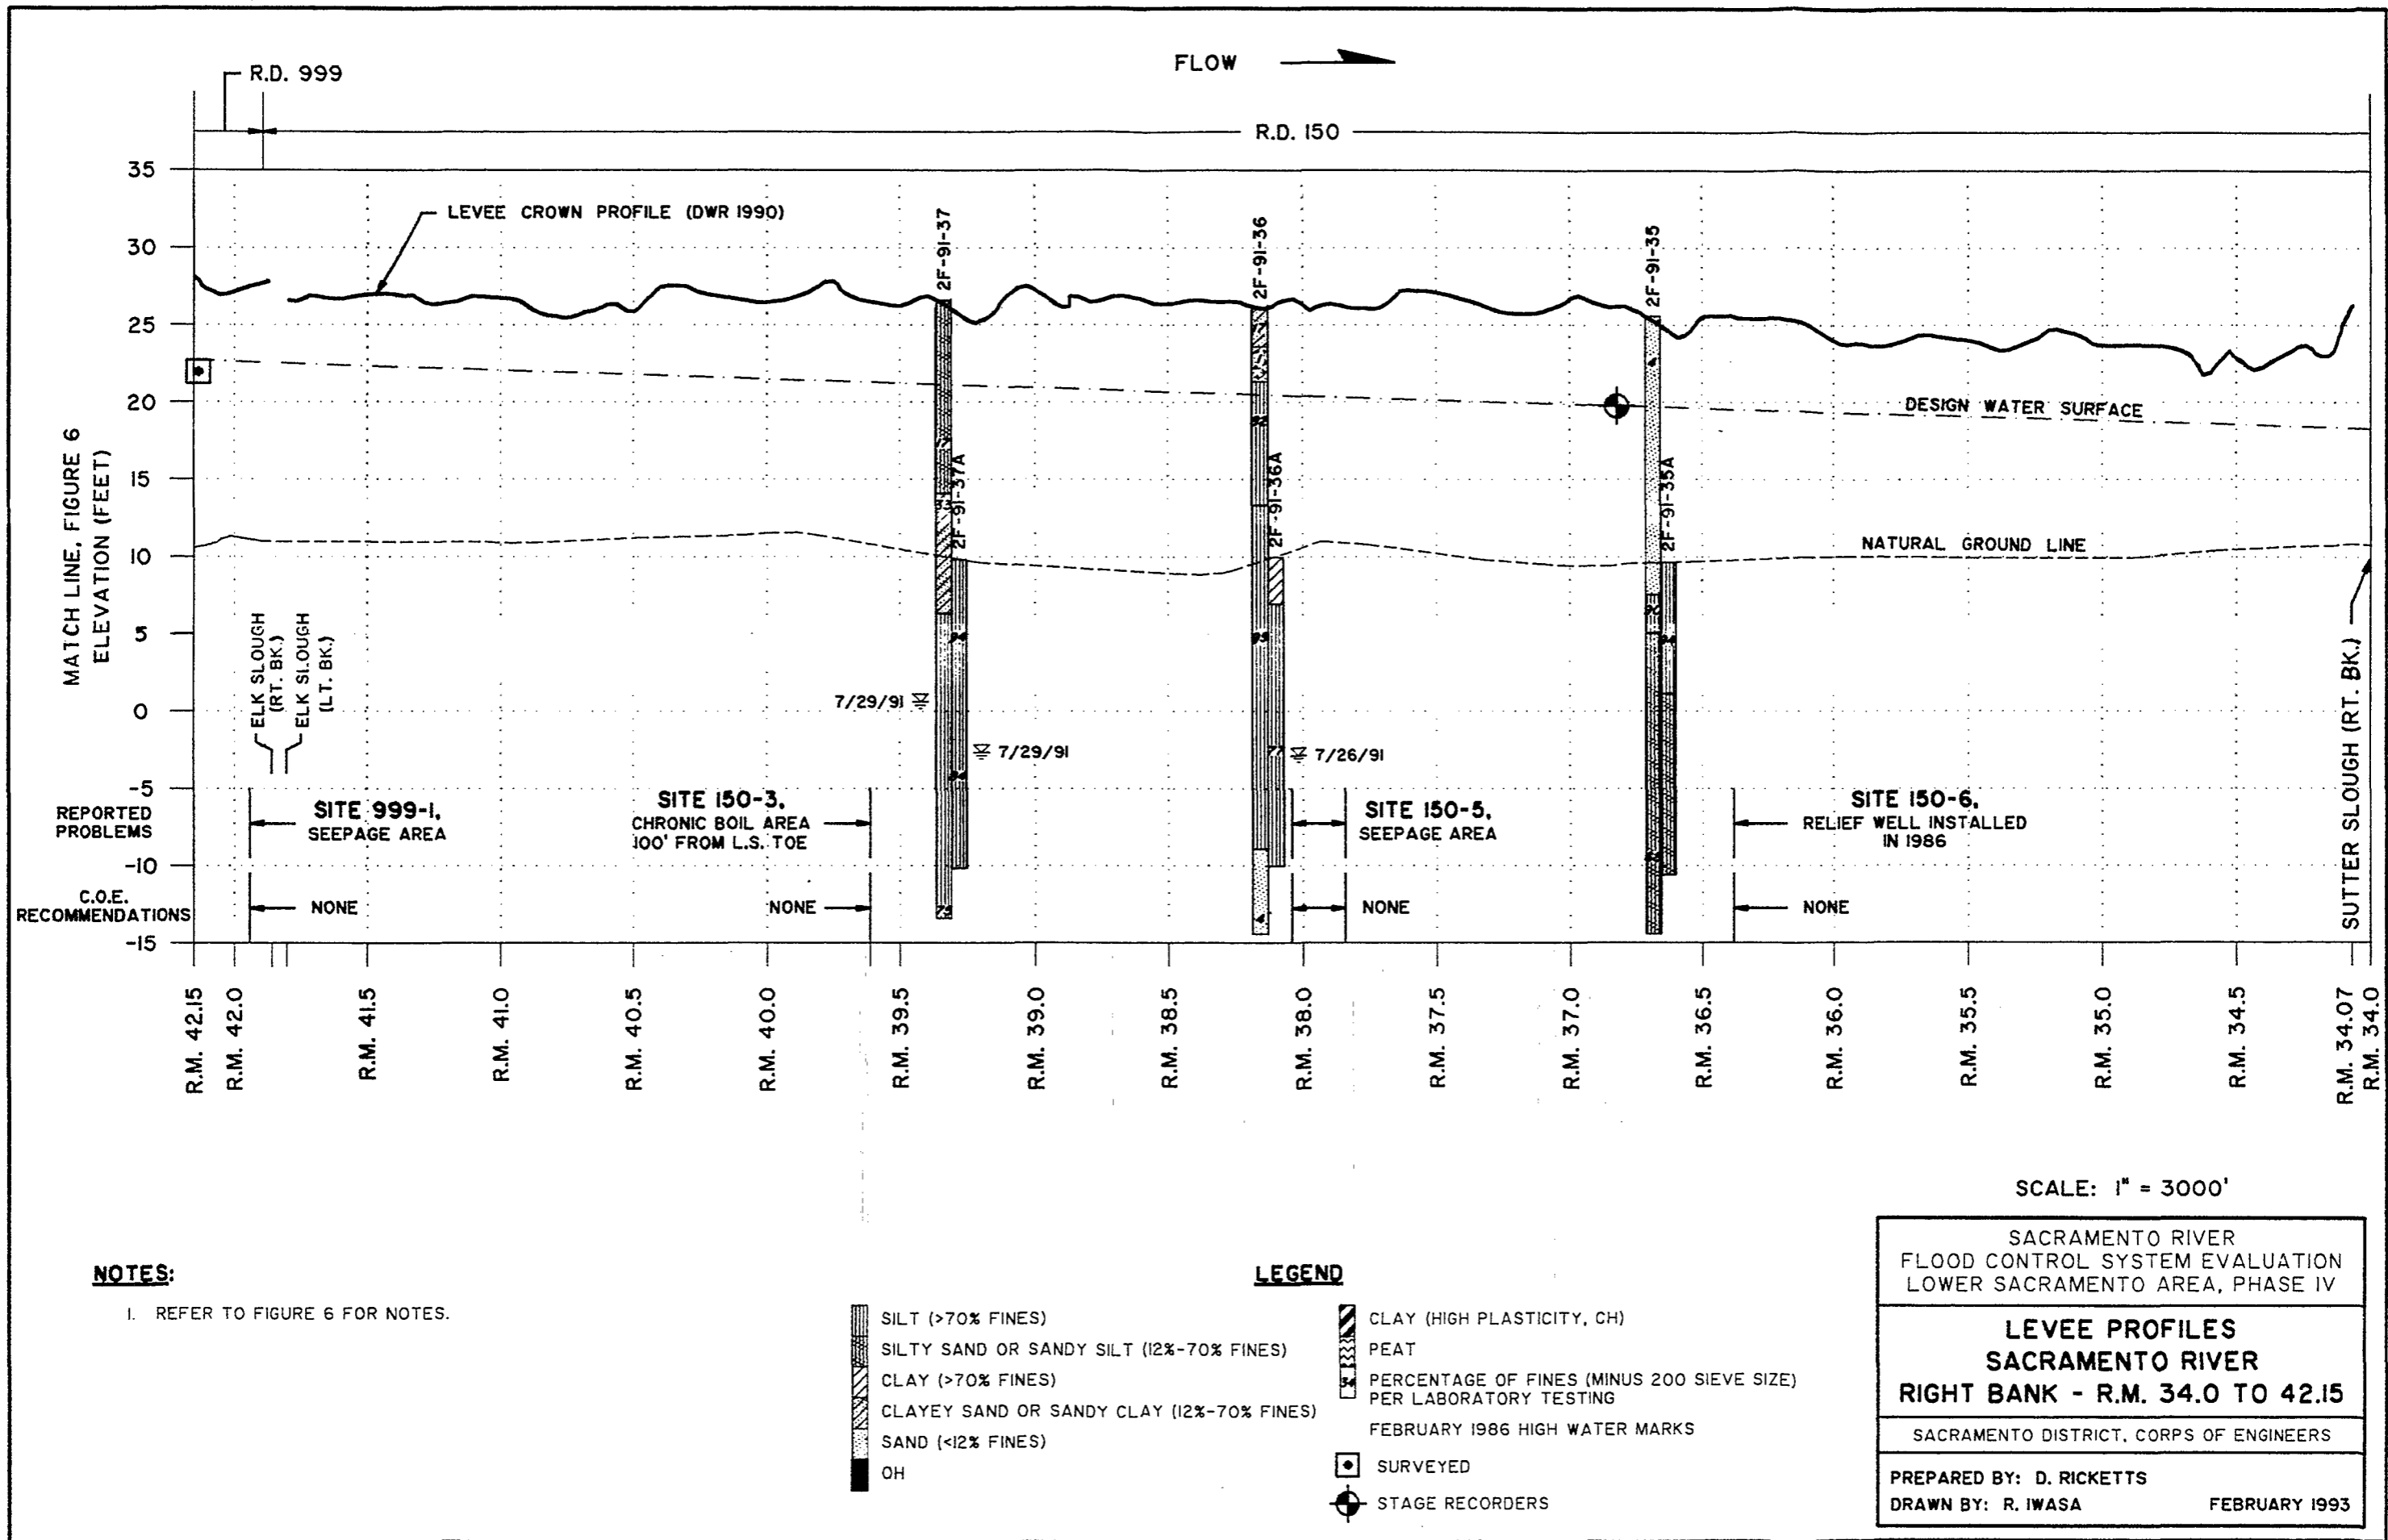
FIGURE 7

The levee profile is shown on Figures 6 and 7. Based on the available boring data, the levee soils are typical of other levee soils along the Sacramento River. One of the three levee borings, 2F-91-35 indicate clean levee materials, ie poorly graded sand (SP). The other two borings indicate finer grained silty sand (SM) and silt with sand (ML). The foundation conditions are consistent and consist of silt (ML) to silt with sand (ML).

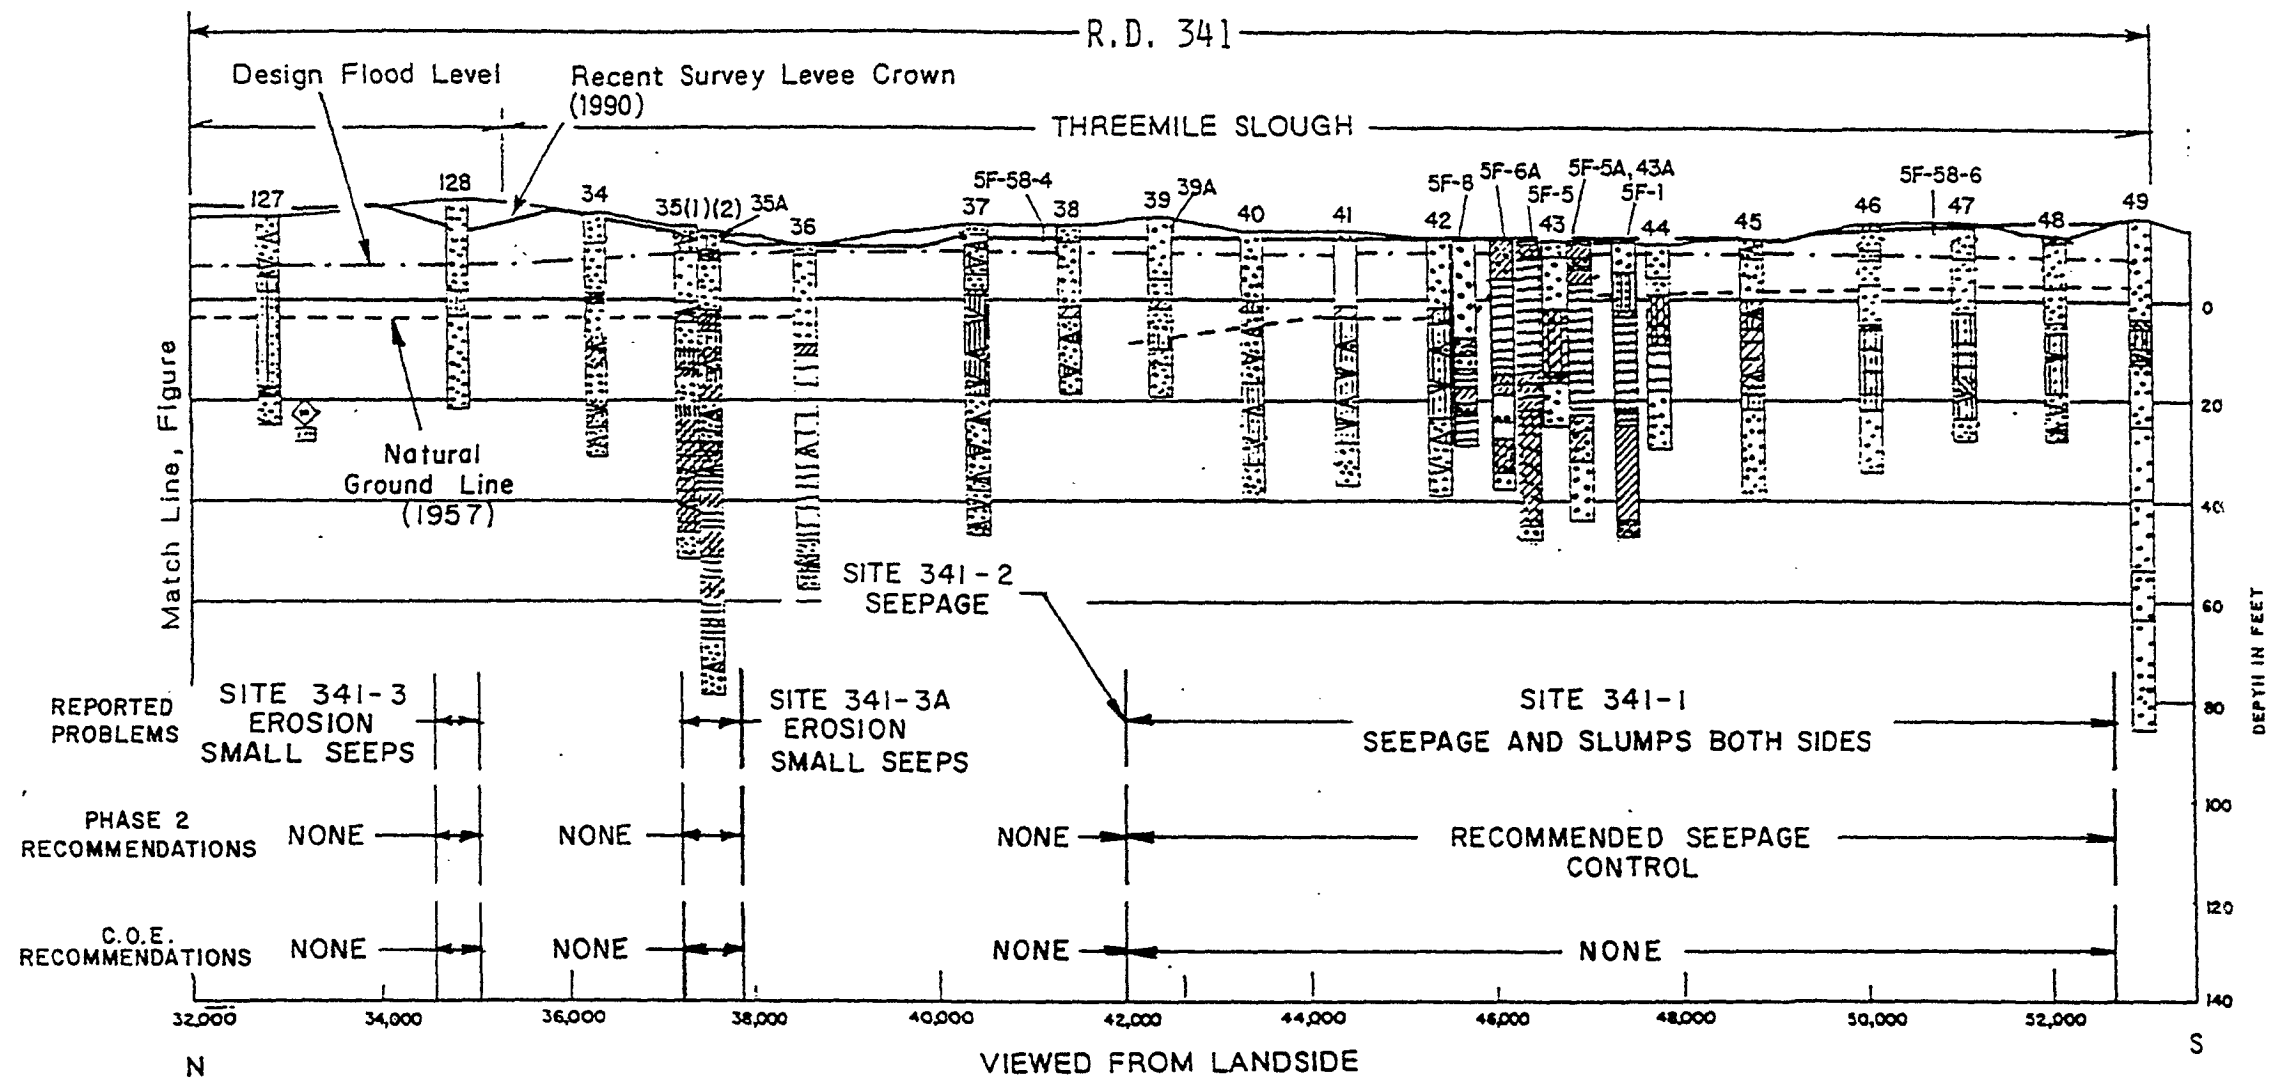
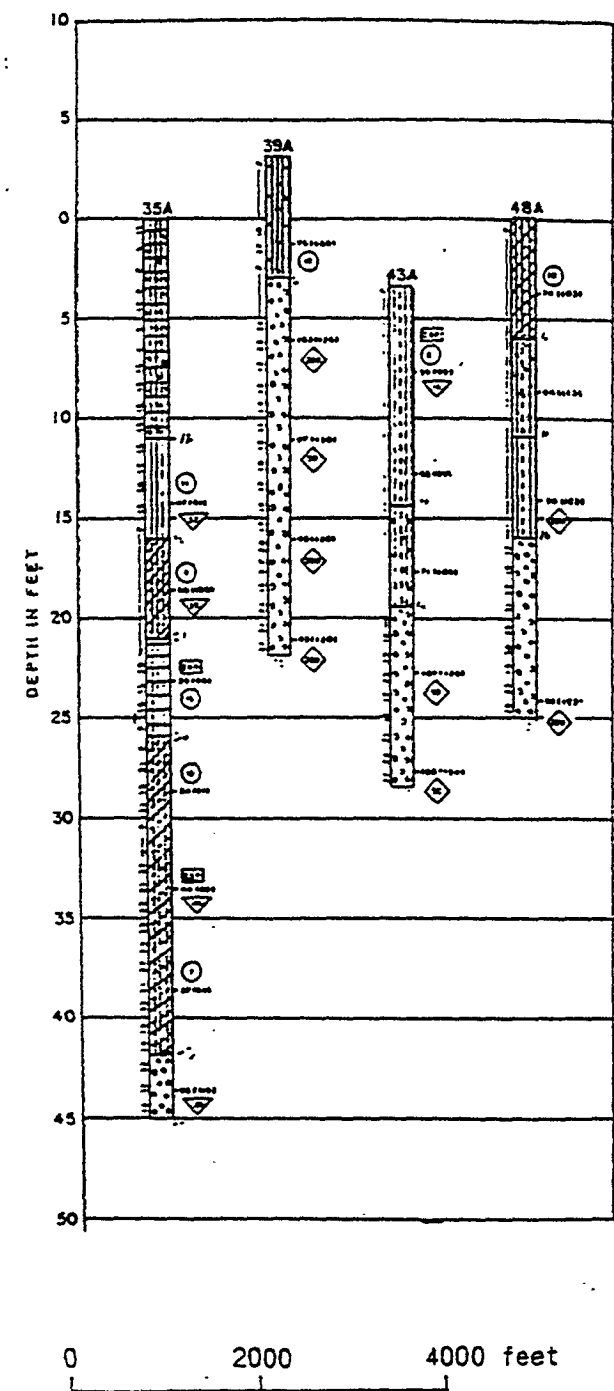
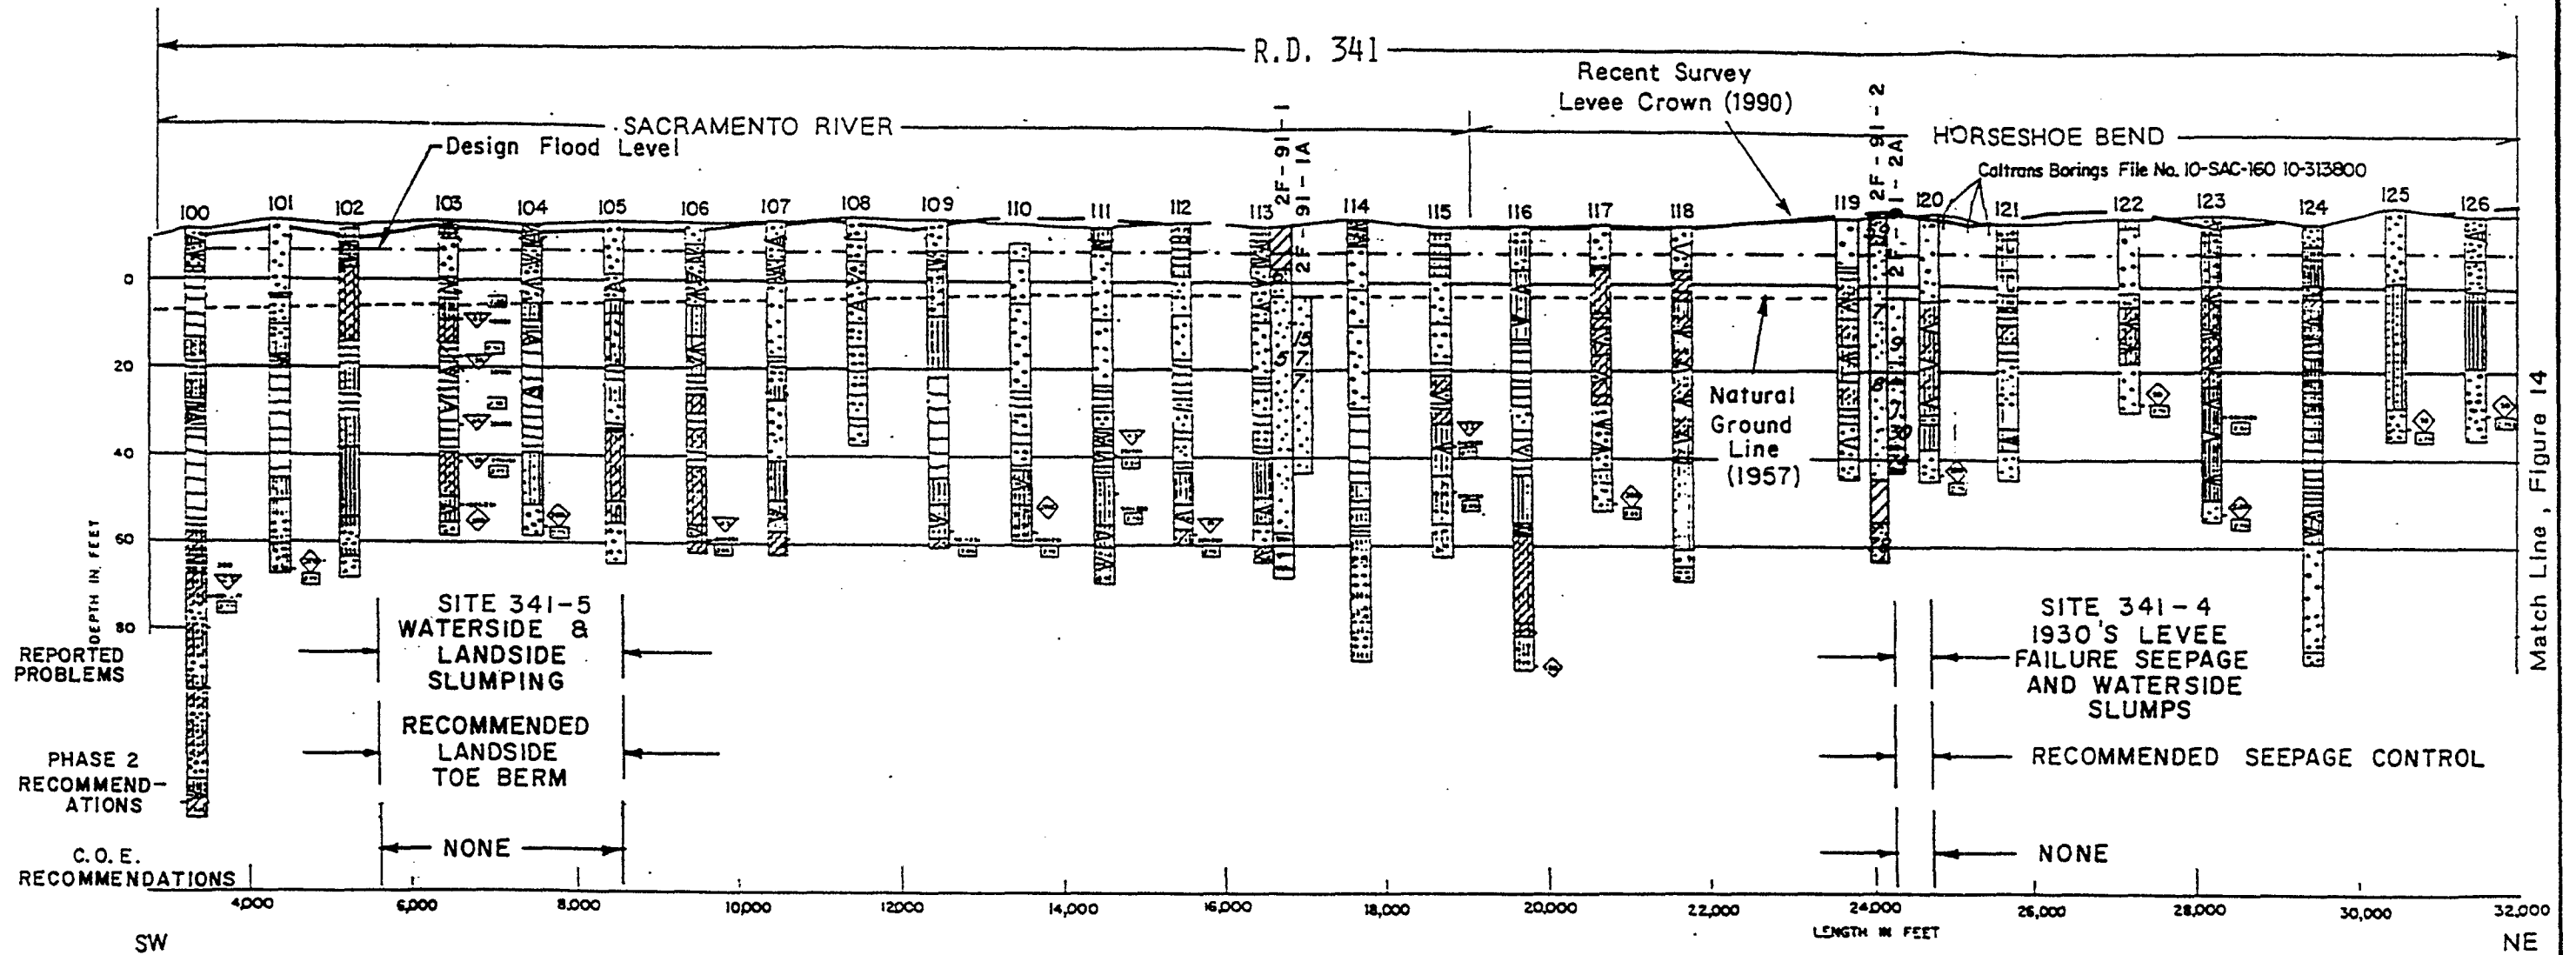
FIGURE 15

The levee and foundation profile is shown on Figures 13 through 15. Levee soils along the Sacramento River and Horseshoe Bend are primarily sand and silt soils which have been dredged from the Sacramento River and Threemile Slough. As indicated on Figure 15, the foundation materials consist of interbedded deposits of sand, silts, clays, and peat of varying thicknesses. The peat deposits vary in thickness from about 20 to 40 feet. The levee height in this reach varies from approximately 10 to 20 feet. The landside and waterside slopes are variable and range from approximately 1V on 2H to 3H.

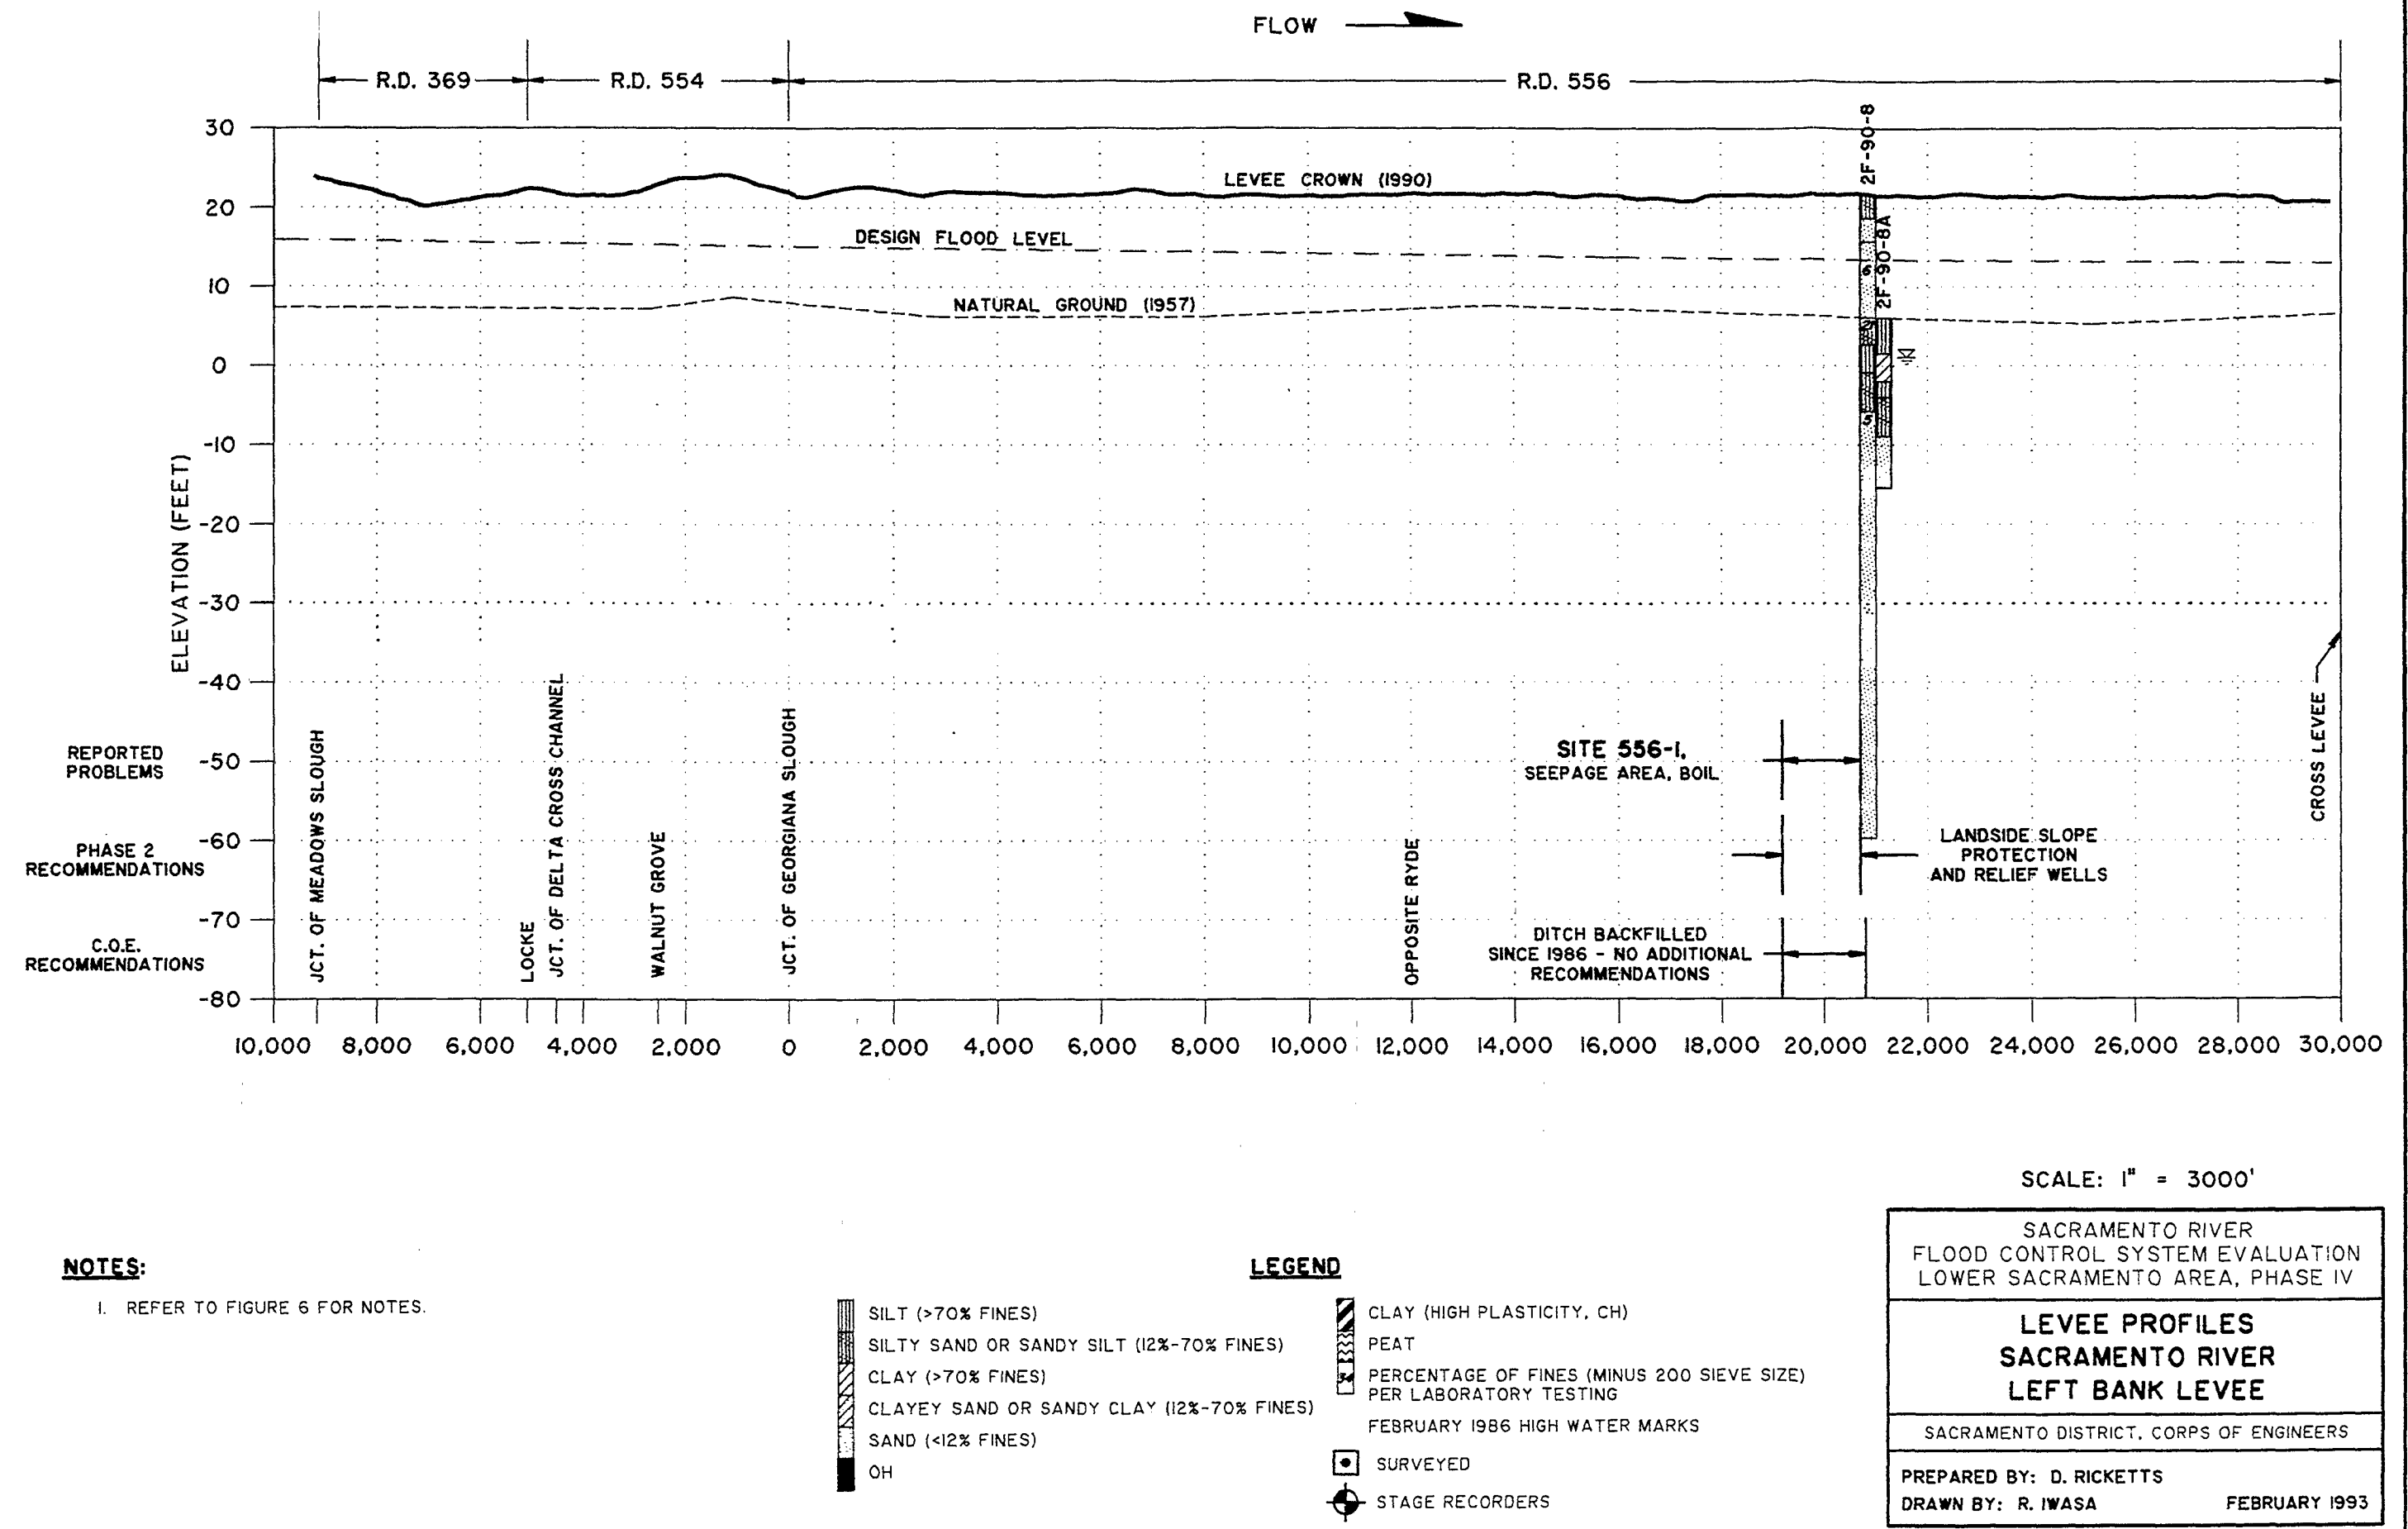
FIGURE 16

The levee and foundation profile is shown on Figure 16. The levee in this reach of the Sacramento River is typically 15 feet in height with a crown width of about 20 feet. The levee crown is paved and in excellent condition. Landside and waterside slopes are variable, typically ranging between 1V on 2H to 3H. Borings 2F-90-8 and 8A indicate the levee materials consist of loose to medium dense sand and silty sand while the foundation is similar with intermittent layers of clay or silt in the upper 10 feet. The foundation material below about 15 feet to at least the depth of boring 2F-90-8 (66 feet below original ground surface) consists of clean sand deposits with minor amounts of gravel to 1/2-inch diameter.

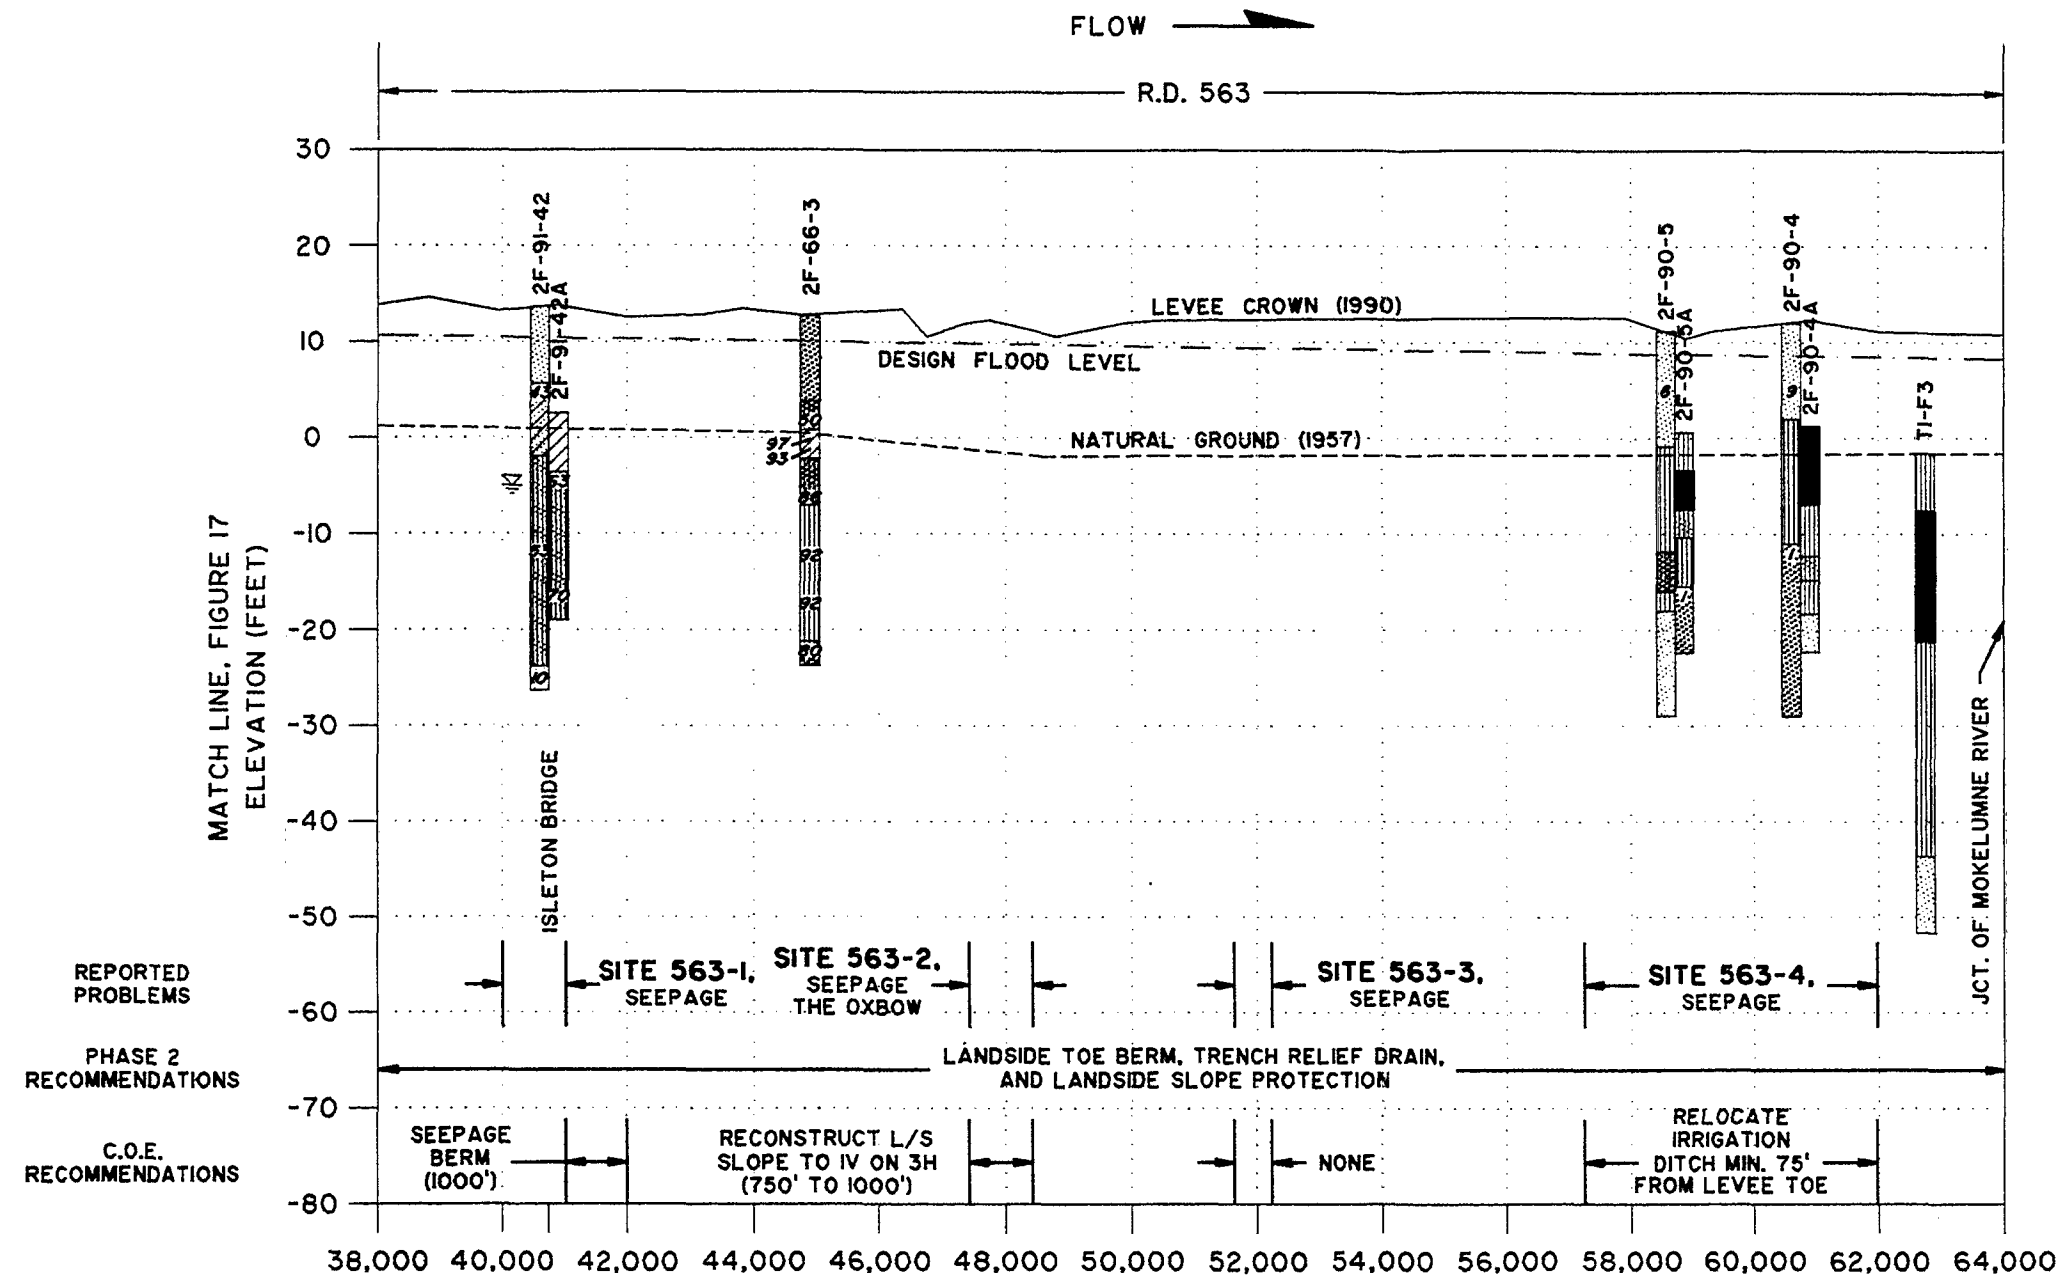
FIGURE 18

Site 563-1, was identified upstream of the Isleton Bridge in the phase two study. Based on field observations made in the phase three investigation, this site should have been located downstream of the Isleton Bridge as shown on Figure 18. It extends for about 1000 feet downstream of the Bridge. The levee material in this area consists of clean sand and although not apparent from the two borings at this location, it was determined during the phase three site inspection that the upper foundation soils also consists of clean sand. Seepage emerges in this reach from the lower portion of a mildly sloping and undulating sand berm. Damp soil conditions and water loving plants exist in an area about 40 feet from the levee landside toe (Photo 4).

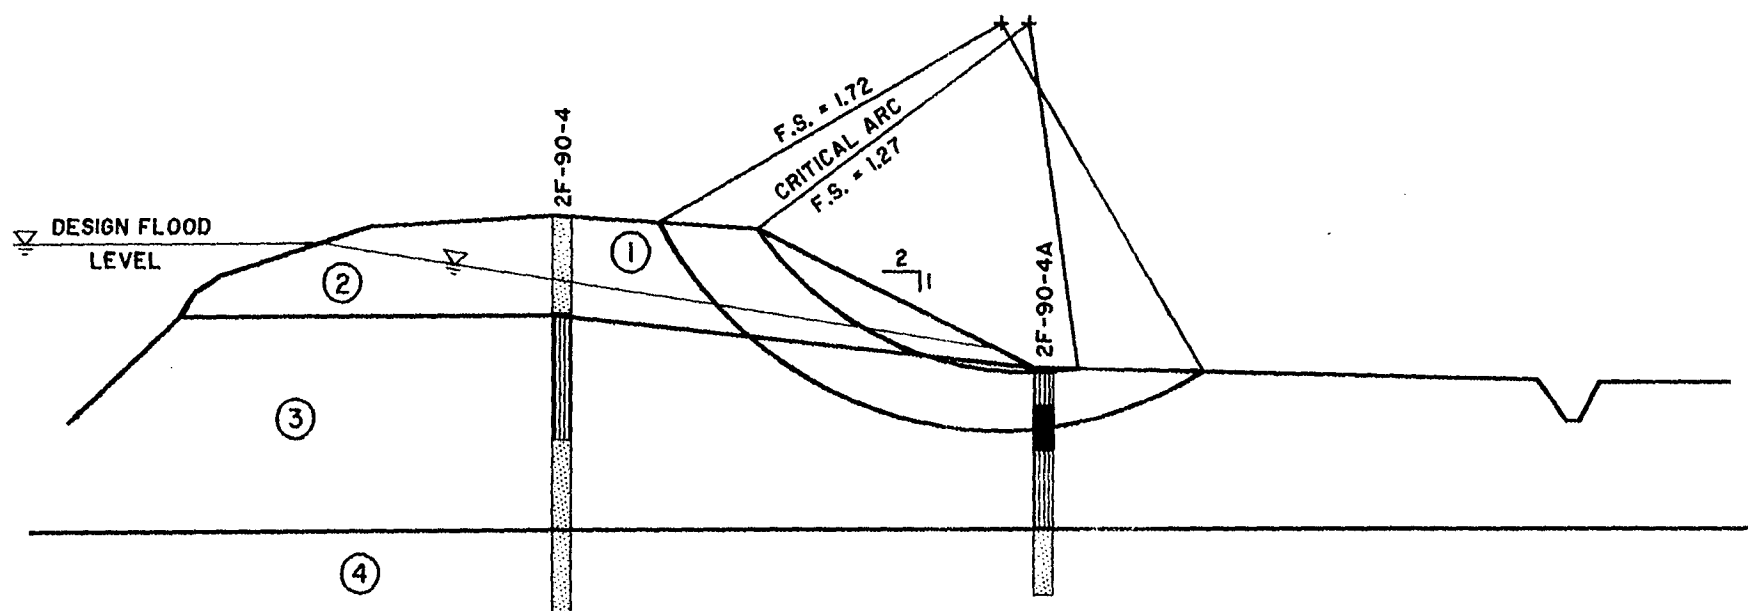
FIGURE 19A

A slope stability analysis of one levee cross section was performed in the phase two study at Site 563-4. The result of the analysis was that the levee had a minimum factor of safety of 0.8. Theoretically, failure would have already occurred. A review of the phase two report concluded that assumptions used including soil shear strength and assumed water surface were overly conservative. A reanalysis performed during phase three study using resulted in a minimum factor of safety of 1.27 (Figure 19A). This is slightly less than normal criteria of 1.4. However, given the conservatism used in this analysis and performance history, the slope stability is judged as acceptable. The history of seepage and site conditions, however, do indicate that foundation conditions are susceptible to piping. As can be seen on the levee profile in Figure 18, clean sand deposits underlie the upper foundation silt deposits. Irrigation ditches can intercept the foundation clean sand layers and result in significant seepage and/or foundation piping. Some portions of the irrigation ditch in this area are located near the levee toe. To decrease the potential for piping of foundation material, it is recommended that where the existing irrigation ditch is closer than 75 feet to the levee toe, it be backfilled and relocated a distance of at least 75 feet from the levee toe.

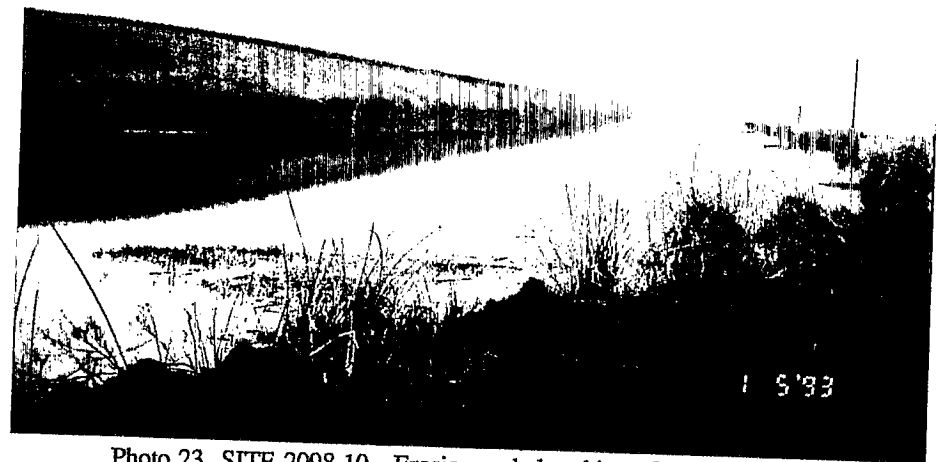
Photo 23 SITE 2098-10 Erosion and sloughing of L/S slope. 1/5/93
